Worldwide repairs carried out with PolymerMetal®

REP-# 046

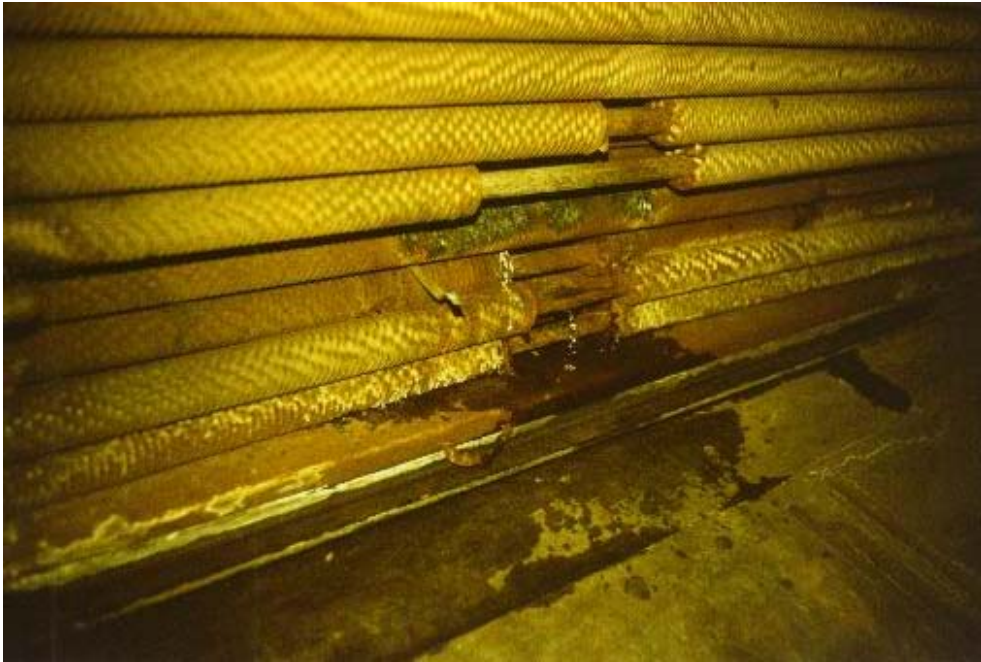
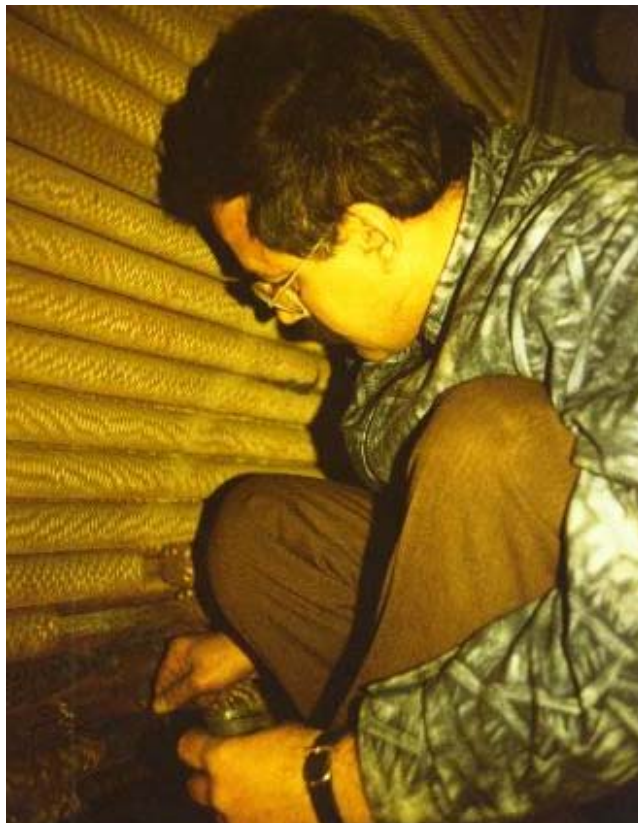
Sealing of a cooling water pipe made of steel without switching off the plant. Cause of the damage was material fatigue. The repair was carried out with MM-metal UW with Hardener UW3 and MM-Fabric tape (glass fibre).
