Worldwide repairs carried out with PolymerMetal®

REP-# 102

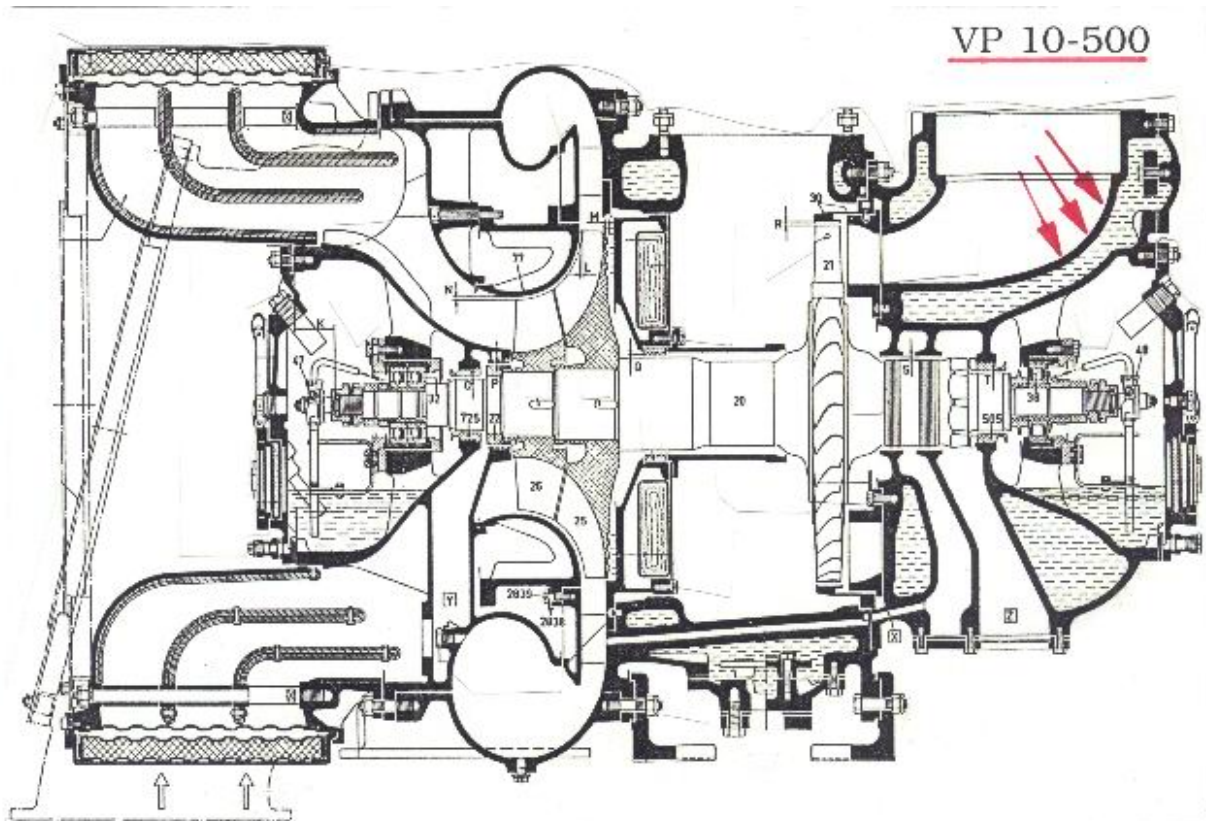
Repair of a ship's turbocharger with VP 10-500. Scourings, cracks and apertures from the gas entrance to the cooling water side were repaired with VP 10-500. For the reinforcement two layers of MM-Fabric tape (glass fibre) were used.
