REP-# 104

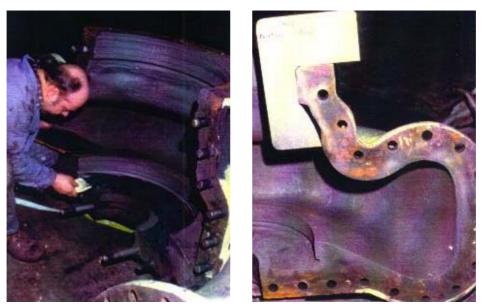
An additional water-centrifugal pump being damaged by erosion and cavitation was rebuilt using Ceramium. Housing and flanged socket were coated inside with VP 10-017.
