Worldwide repairs carried out with PolymerMetal®

REP-# 106

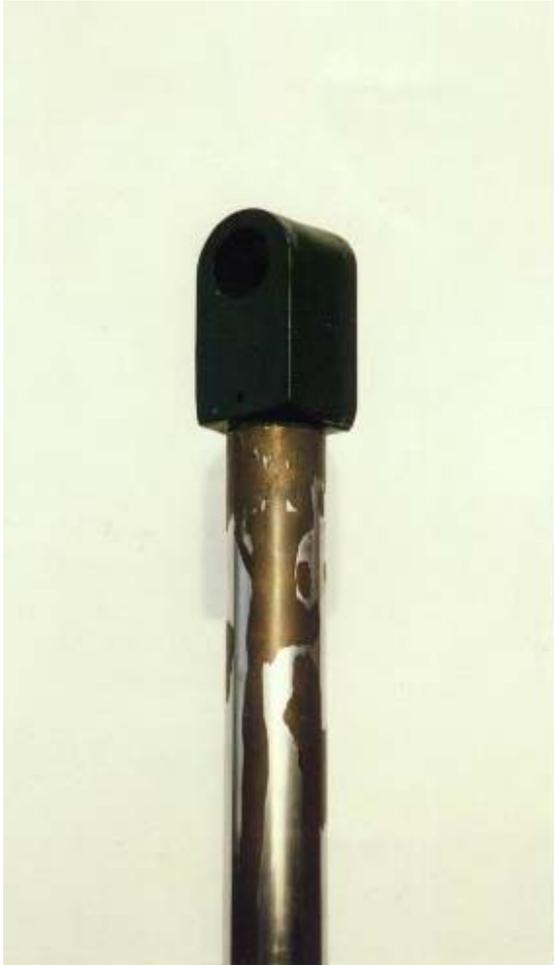
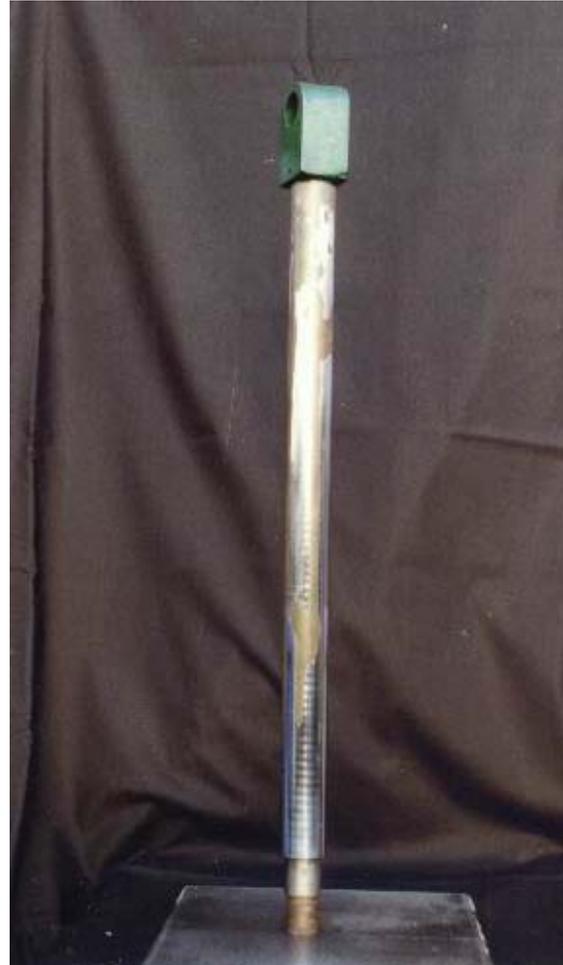
A chrome plated hydraulic piston showed strong surface flaking. As there were thinnest layers and antifriction properties required, the repair was affected with Molymetal.
