REP-#139

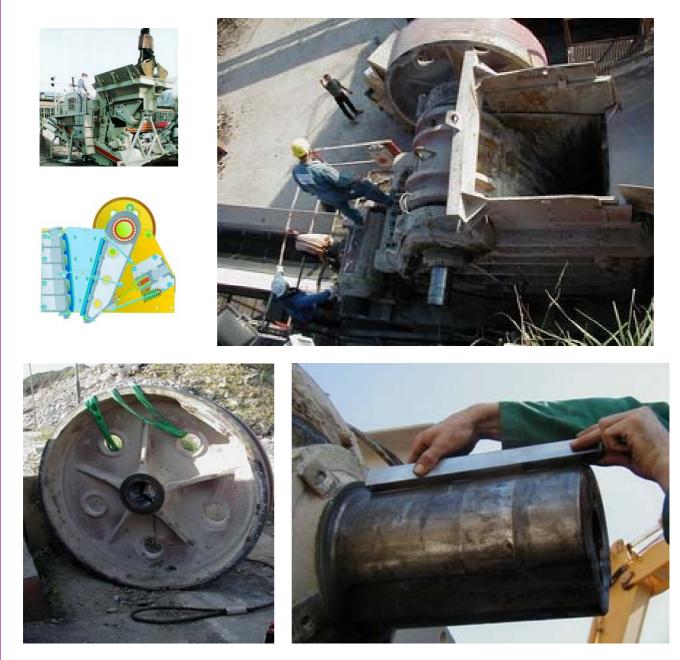
After many years of working, the worn-out rock shaft of a crushing plant for recycling demolition material was repaired with MM-metal SS-steel 382 in September 2002. First the driving fly wheel was carefully dismantled to receive access to the shaft. After the surface preparation of the up to 1 mm worn-out shaft area, MM-metal SS-steel 382 was applied and then machined down to the desired diameter. A replacement due to the necessary dismantling of the damaged shaft, the purchase and the assembly of a new shaft, would have involved considerable additional costs and time. An examination 4,5 years later (March 2007) has come to the result, that the repaired work piece is still in function without any complaints.
