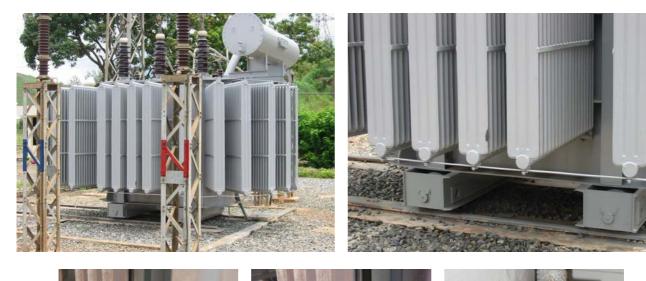
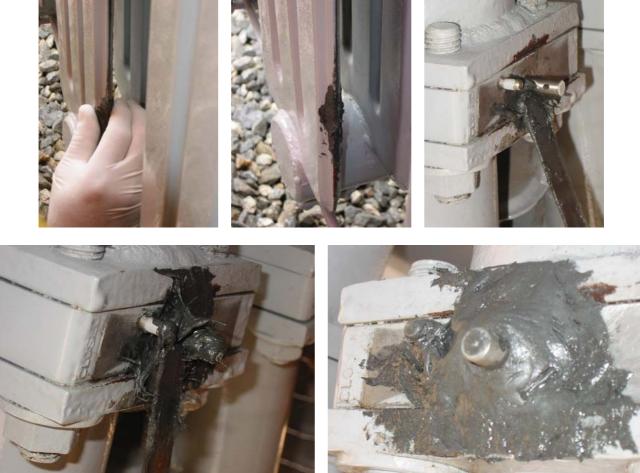
A damaged power transformer located in a steel plant has been repaired by using MM-metal oL-steelceramic and Hardener yellow.
