REP-# 162

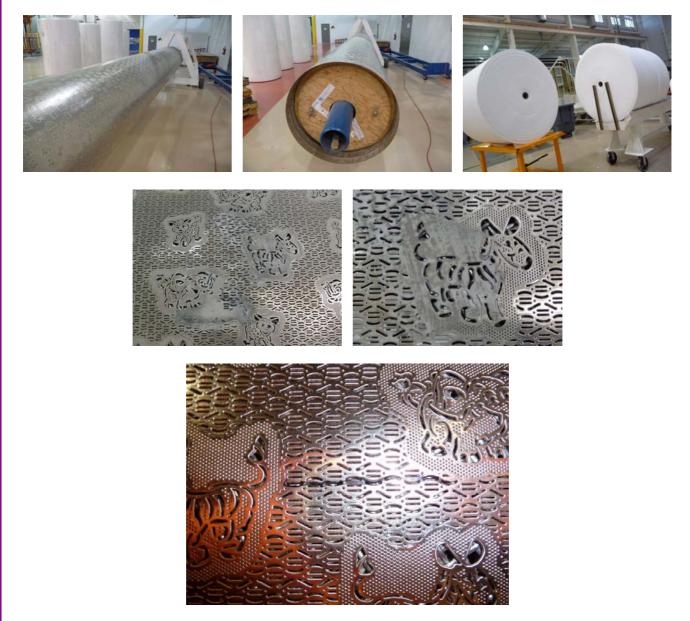
In a nickel drum which is used for the coinage of patterns on fleece materials cracks and fractures places were detected. The fractured places of the very thin-walled (2 mm) drum had to be stabilised. Without a repair there was a danger of fleece material getting stuck in the drum causing further damages. First the damaged areas have been grinded and smooth hollow-shaped passages have been created. After roughening and cleaning with acetone Ceramium BD was applied on the areas and cracks and fractures were filled. Those places were grinded again, adapted and the outlines were milled. Afterwards the surface was coated with Sealium. After end of the repair works the trommel screen could be successfully put into operation again under the usual operation conditions (working pressure 170 bar).
