## Worldwide repairs carried out with PolymerMetall®

## **REP-#169**

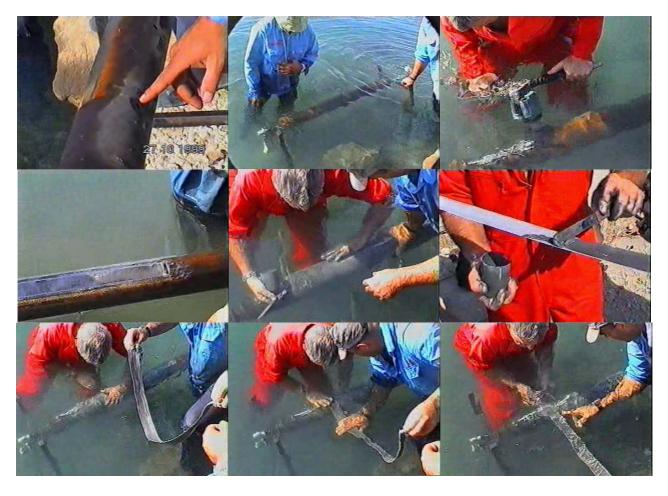
In a approx. 8 m long pipe section of a fuel pipe situated in sea water (location Middle East) of a huge energy provider there was determined by ultrasonic tests a considerable wall thickness recession due to corrosion and erosion. Prior to the decision of a repair of the 16 inch (outer diameter) big piping there was carried out a pre-test. Here were used MM-metal UW together with fabric tapes made off glass fibre. The above photographs show the corresponding test application of a slightly slimmer pipe. After good test results later the real pipe (16 inch outer diameter, original wall thickness ~ 13 mm, wall thickness recession at thinnest spot to approx. 5 mm; in addition to that deep pittings; water temperature during application approx. 14 – 18 °C; operation pressure in pipe approx. 5,5 up to max. 10 bar) was repaired, too. In the end there were used 100 units MM-metal UW / Hardener UW at this operation. There the pipe was prepared/machined (roughened) in the worn area. Then, under water, there was applied a first (base) coat. Afterwards the fabric tapes were prepared – that means they were coated from both sides with the mixed MM-metal UW - and then wrapped around the pipe onto the still not cured base coating. For a good repair success it was important that the pot life, that means the time span which is available for the processing of the material, was kept.
