Worldwide repairs carried out with PolymerMetal®

REP-# 124

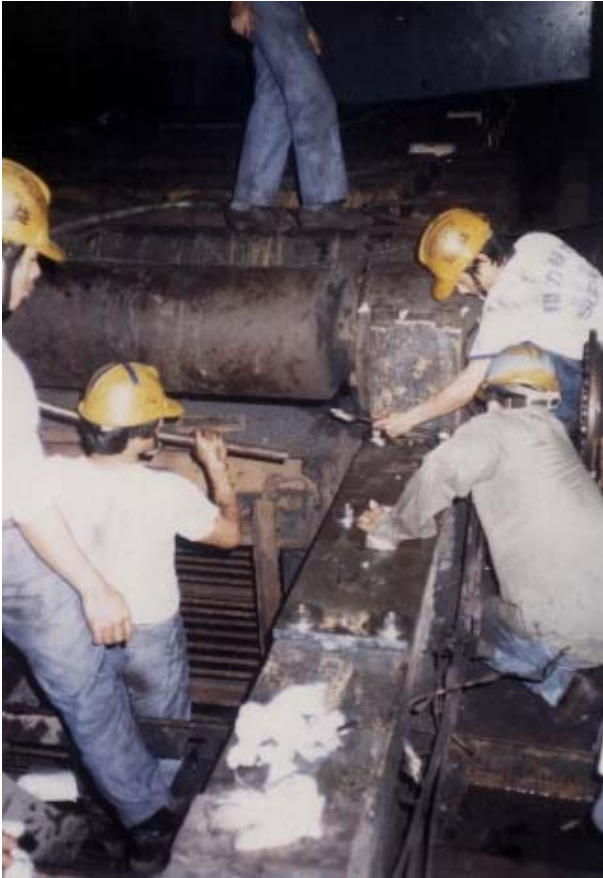
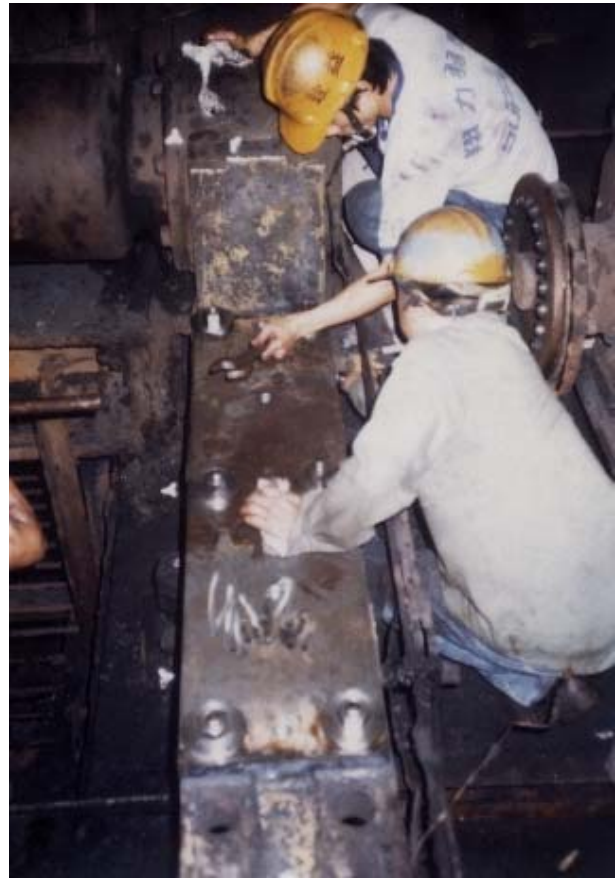
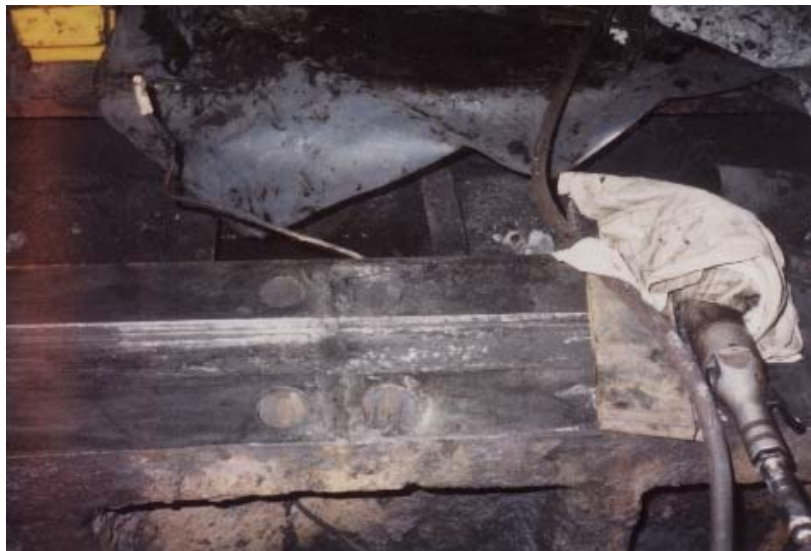
Repairing a corroded and worn out pillow block bedding of a steel sheet rolling line using MM-metal SS-steelceramic. The precise pillow block seat was obtained with the help of a metal plate.
