Worldwide repairs carried out with PolymerMetal®

REP-# 134

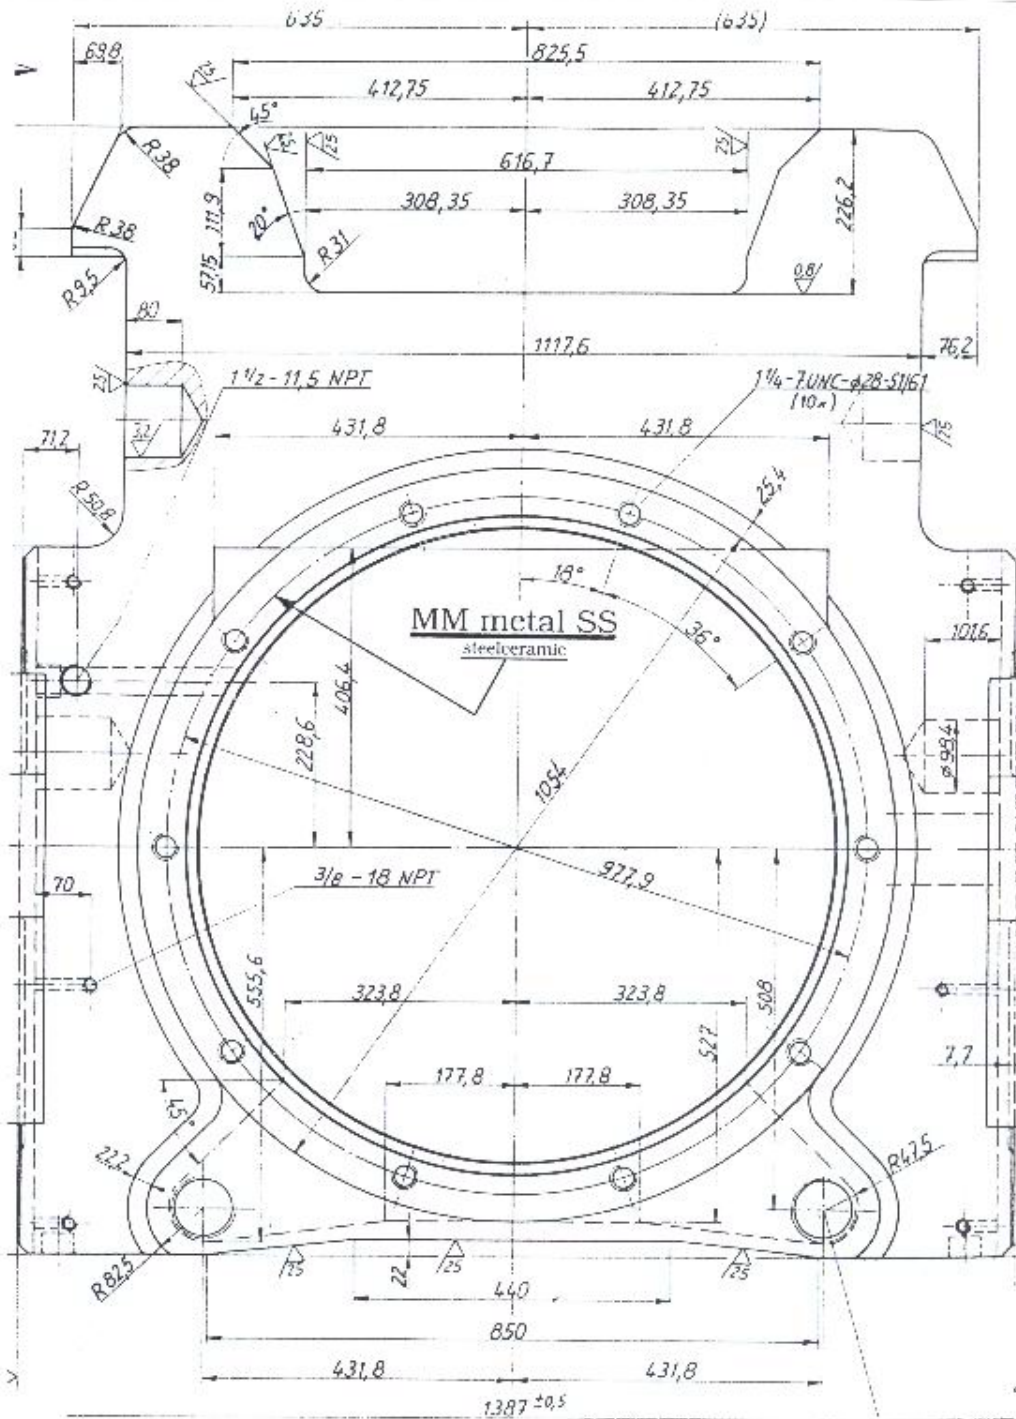
34 damaged back-up rolls bearing houses of a steel work's hot strip mill were modified. The above drawing shows a bearing shell which was damaged by turning of the outer bearing bore. Conventional repairs of these damages would have been executed by welding on, heat-treating and turning to original size. Cheaper and less time intensive is an innovative repair with MM-metal steelceramic and Hardener yellow.
