REP-# 135

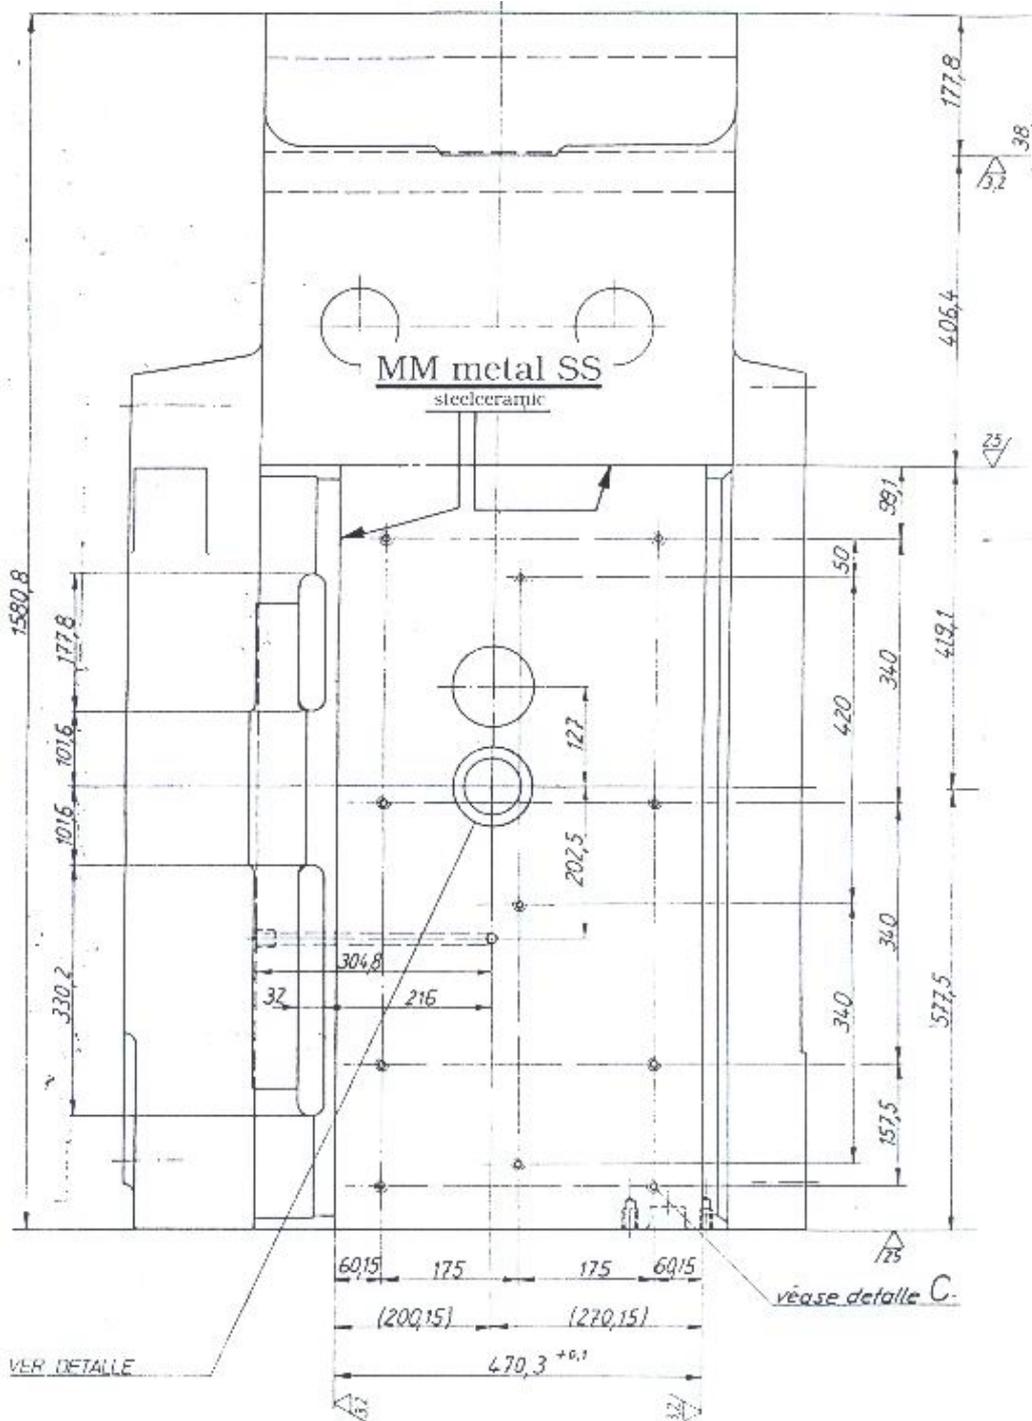
34 damaged back-up rolls bearing houses of a steel work's hot strip mill were modified. The above drawing shows guiding plates as a fixture to the bearing house. To achieve a constant distance to the bearing at unchanged plate thickness, the surface damaged by erosion and mechanical load was restored by MM-metal steelceramic and Hardener yellow.
