Worldwide repairs carried out with PolymerMetal®

REP-#148

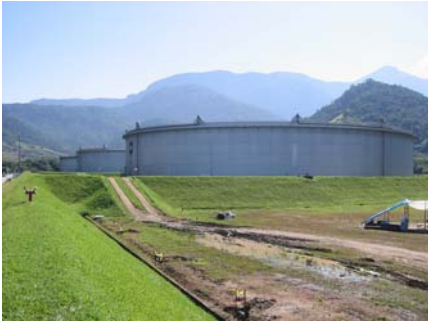
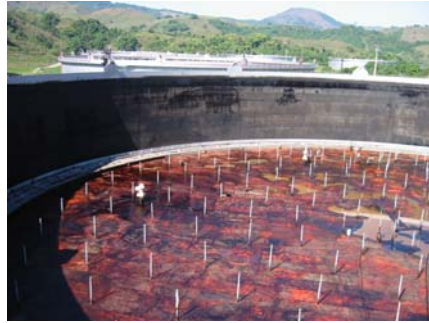
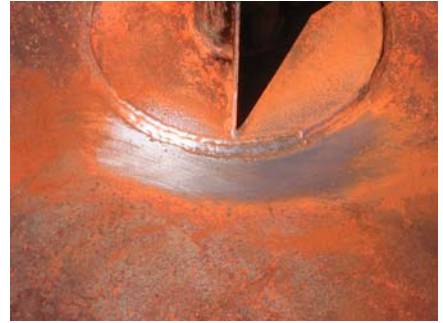
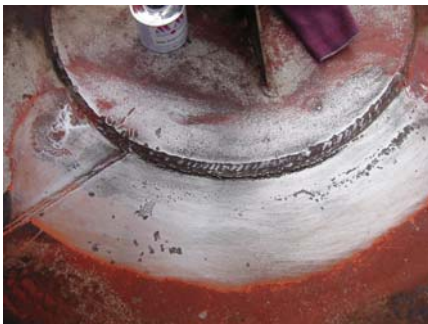
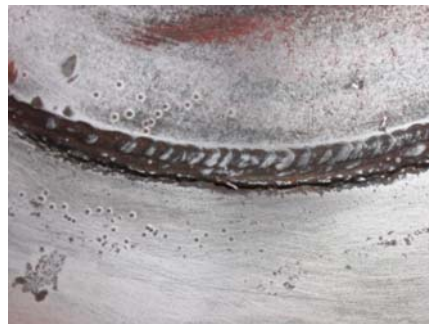
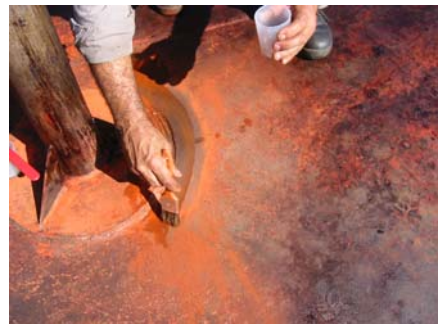
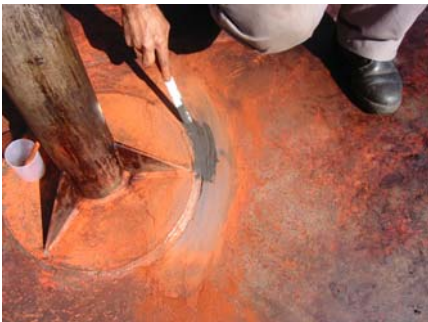
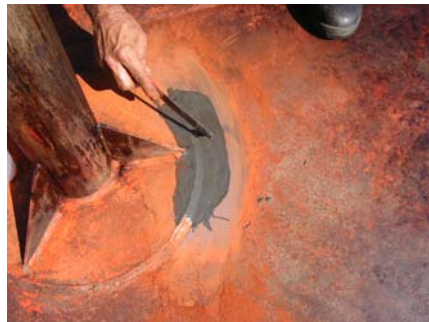
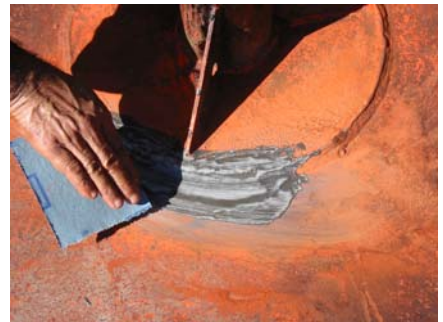
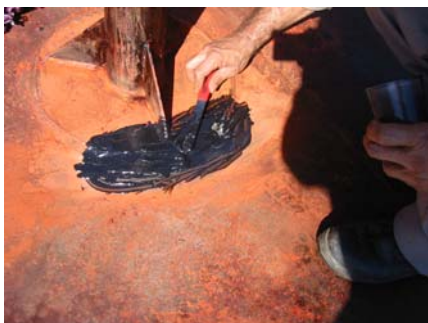
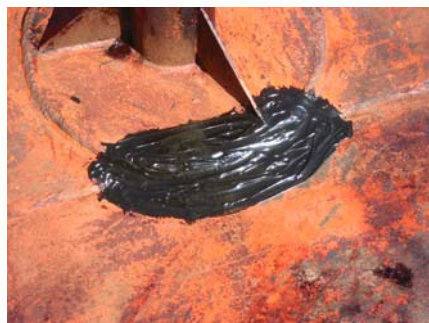
Several holes and damaged spots respectively in the roof of a big tank at an oil refinery were first grinded and cleaned to prepare the surface and then coated with Ceramium. Then the Ceramium was grinded to rough up the surface. Finally a layer of MM-Elastomer was applied to compensate any bigger tensions.
