## Worldwide repairs carried out with PolymerMetal®

REP-# 163

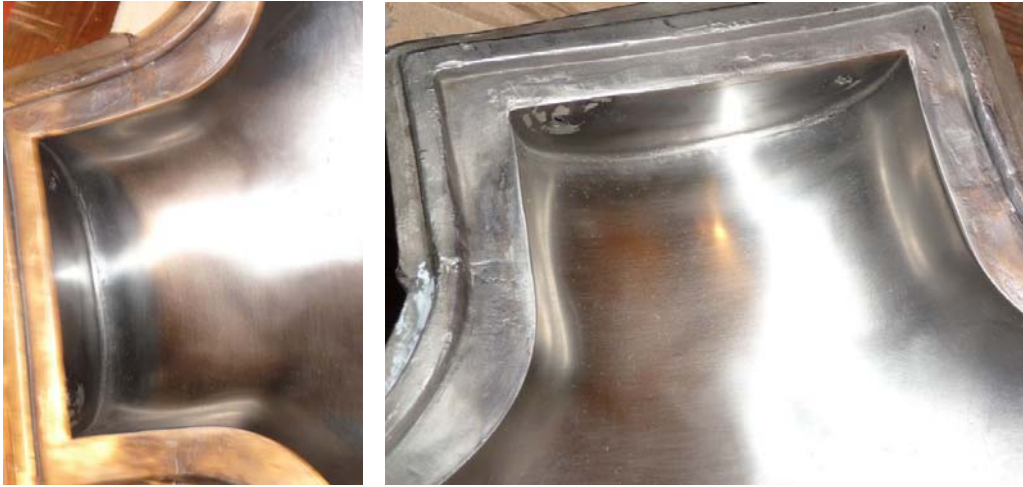
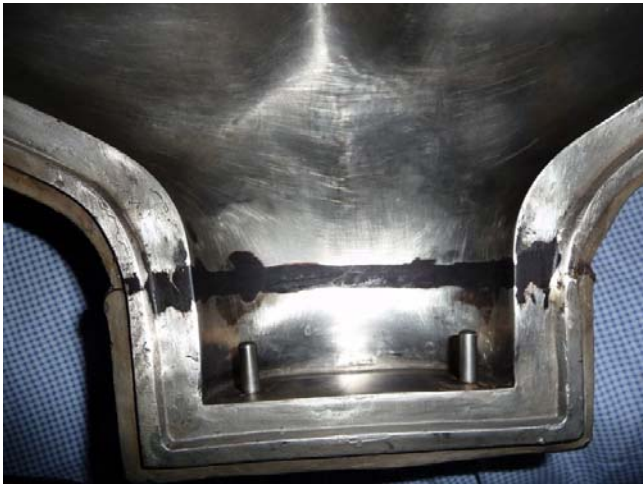
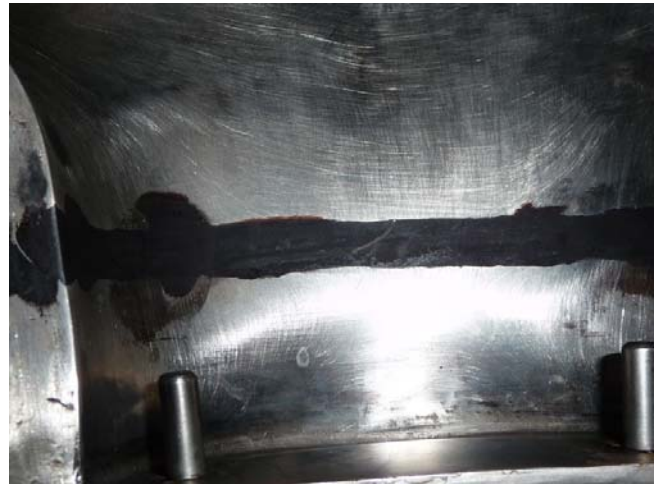
A tool form of nickel for the torsos production of complex medical rubber dummies had to be adapted in the cervical region. The form was first cut in the cervical area. The attempt by soldering to join again the parts of the form being adjusted in the meantime, failed. Leakages by embedded air bubbles occurred in the cast parts in the area of the seam. By the alternative application of Ceramium BD the form could be put into operation again successfully. The seam was grinded 2 mm deep, cleaned with acetone and warmed up in the stove on 100 °C. Then Ceramium BD was applied in the repair area. After sufficient curing of approx. 1 - 1,5 hours the form was grinded and covered with Sealium respectively immersed in Sealium. The result was a clean surface without noticeable passages in the seam. The form stood firm easily the working temperature of 265 °C.
